West Sussex County Council
East Grinstead Stage 3 Traffic
Management Study

Stage 1 Road Safety Audit
February 2012

East Grinstead Stage 3 Traffic Management Study

Stage 1 Road Safety Audit

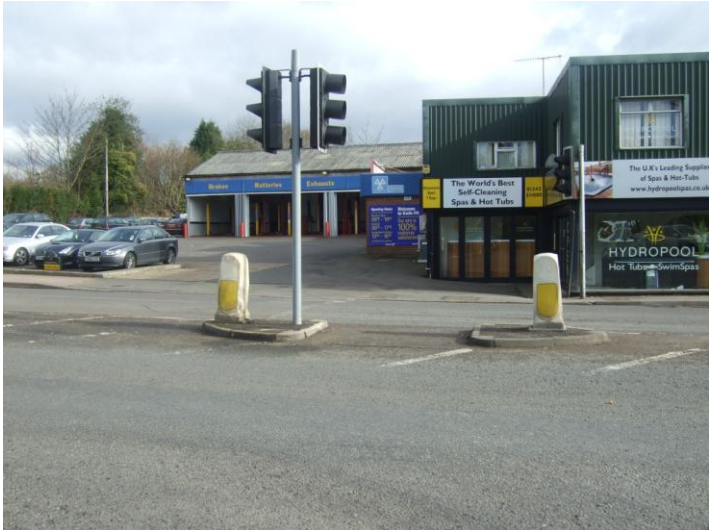
Location Reference No: 5	
<p>Location: Pedestrian crossing on A22 Eastbourne Road approach (Drg Nos: 5107918/TP/PD/101 & 102)</p>

<p>Photo taken looking eastwards at the pedestrian crossing on the A22 Eastbourne Road approach to the A264 Copthorne Road junction</p>
<p>Problem:</p>	<p>Junctions - Vehicles exiting the properties on the eastern side of the carriageway making use of the pedestrian crossing</p>
<p>Summary:</p>	<p>There is an extended dropped kerb in front of the properties on the eastern side of the pedestrian crossing. Vehicles exiting these properties have been observed to exit the properties by using the dropped kerb on the pedestrian crossing, thereby crossing the pedestrian area to access the junction, past the stop line. This could lead to both vehicle/vehicle conflicts and pedestrian/vehicular conflict within the signals controlled area.</p>
<p>Recommendation:</p>	<p>Consider relocating the pedestrian crossing, or ensure that vehicles cannot exit the property within this area of the carriageway.</p>

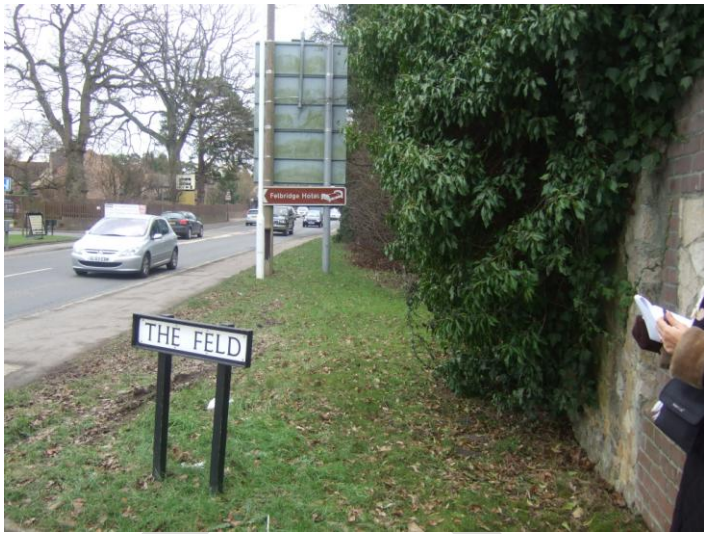
Location Reference No: 8	
<p>Location: A22 London Road western kerb alignment (Drg No: 5107918/TP/PD/103)</p>

<p>Photo taken looking south onto the A22 London Road northbound from The Feld</p>
<p>Problem:</p>	<p>Local Alignment - Widening of western kerblines reduces visibility</p>
<p>Summary:</p>	<p>The widening of the western kerblines will result in the give way line on The Feld approach to be moved back. This can reduce the visibility splay for vehicles exiting as it may be obstructed by mature trees and street furniture.</p>
<p>Recommendation:</p>	<p>Assess and provide sufficient south visibility for vehicles at The Feld and insure that agreements are in place for sight lines to be maintained.</p>

Location Ref.	Problem	Recommendation	Accepted/ Rejected	Designer's Response
	Summary: The drawings indicate the provision of two short lanes merging into one lane on the southbound exit of the junction. The right turn from A264 Copthorne Road seems to be a main route for HGVs and articulated trucks. Although the turning analysis indicates that there is sufficient carriageway space available for a HGV and a large van to make this right turn together, at higher speeds these vehicles would be in conflict, causing side swipe collisions.	analysis.		right and left turn manoeuvres.
8	Location: A22 London Road western kerb alignment (Drg No: 5107918/TP/PD/103) Problem: Local Alignment - Widening of western kerblines reduces visibility Summary: The widening of the western kerblines will result in the give way line on The Feld approach to be moved back. This can reduce the visibility splay for vehicles exiting as it may be obstructed by mature trees and street furniture.	Assess and provide sufficient south visibility for vehicles at The Feld and ensure that agreements are in place for sight lines to be maintained.	Accepted	As part of the design a new footway will be provided, the stone wall relocated and vegetation cleared. At detailed design the proposals will ensure appropriate visibility will be provided.

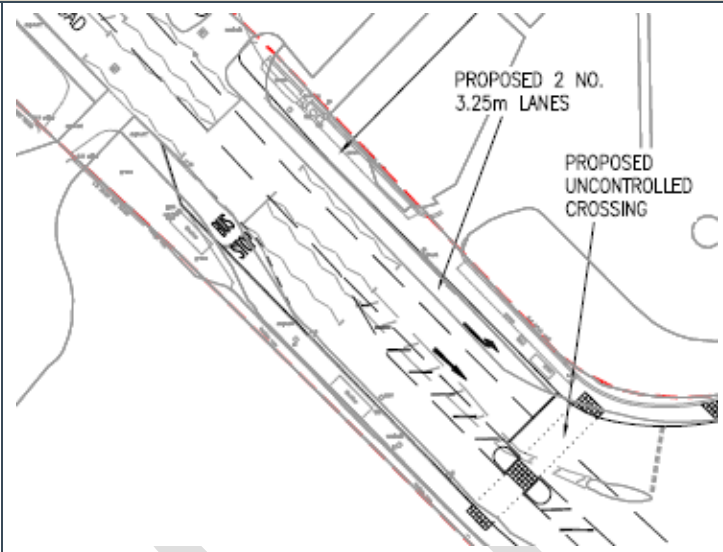
Location Reference No: 14	
<p>Location: Northbound bus stop (Drg No: 5107918/TP/PD/301 & 302)</p>

<p>Extract of drawing 301</p>
<p>Problem:</p>	<p>General - Length of bus stop reduced</p>
<p>Summary:</p>	<p>The design drawings illustrate a shortened bus stop in comparison to what is currently provided. There is insufficient space for a bus to stop at this stop and not block the northbound lane away from the junction. This could lead to vehicles crossing over the hatch markings to overtake stationary buses.</p>
<p>Recommendation:</p>	<p>Lengthen the bus stop to accommodate double decker buses. Adjust road markings to enable vehicles to overtake stationary buses, without the need to enter the hatch markings.</p>

Location Ref.	Problem	Recommendation	Accepted/ Rejected	Designer's Response
	<p>Summary: The design drawings illustrate a shortened bus stop in comparison to what is currently provided. There is insufficient space for a bus to stop at this stop and not block the northbound lane away from the junction. This could lead to vehicles crossing over the hatch markings to overtake stationary buses.</p>	<p>stationary buses, without the need to enter the hatch markings</p>		
15	<p>Location: A22/Lingfield Road junction (Drg No: 5107918/TP/PD/301)</p> <p>Problem: Junctions - Southbound lane through junction could be obstructed by right turning traffic</p> <p>Summary: The southbound traffic on A22 London Road travels in the offside lane. The alignment tends to deviate slightly to the left, and then swing right, quite sharp, to align with the kerb exiting Lingfield Road. The sharp deviation could cause drivers to misjudge the kerb alignment and there is a risk of the kerb being struck. This situation is made worse due to a right turn lane arrangement where there is a risk of vehicle side swipes.</p>	<p>Alter the alignment of the junction to remove the conflict</p>	Accepted	<p>This is a replication of the WSCC proposal for the A22 / Lingfield Road scheme. There is a risk of collision for southbound traffic on the A22 with the traffic island and with vehicles turning right into Lingfield Road. The proposed alignment will need to be reviewed at the next design stage.</p>

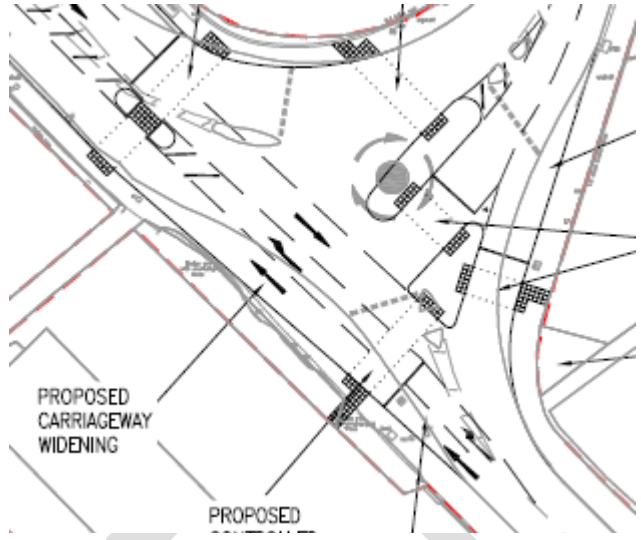
Location Reference No: 15	
<p>Location: A22/Lingfield Road junction (Drg No: 5107918/TP/PD/301)</p>

<p>The diagram is a technical drawing of a road junction. It shows a main road (A22) and a crossing road (Lingfield Road). The drawing includes various lane markings, arrows indicating traffic flow, and dashed lines representing proposed changes. Two labels with arrows point to specific areas: 'PROPOSED CARRIAGEWAY WIDENING' and 'PROPOSED'. The drawing is detailed, showing lane widths, kerbs, and proposed lane configurations.</p>
<p>Problem:</p>	<p>Junctions - Southbound lane through junction could be obstructed by right turning traffic</p>
<p>Summary:</p>	<p>The southbound traffic on A22 London Road travels in the offside lane. The alignment tends to deviate slightly to the left, and then swing right, quite sharp, to align with the kerb exiting Lingfield Road. The sharp deviation could cause drivers to misjudge the kerb alignment and there is a risk of hte kerb being struck. This situation is made worse due to a right turn lane arrangement where there is a risk of vehicle side swipes.</p>

<p>Recommendation:</p>	<p>Alter the alignment of the junction to remove the conflict.</p>

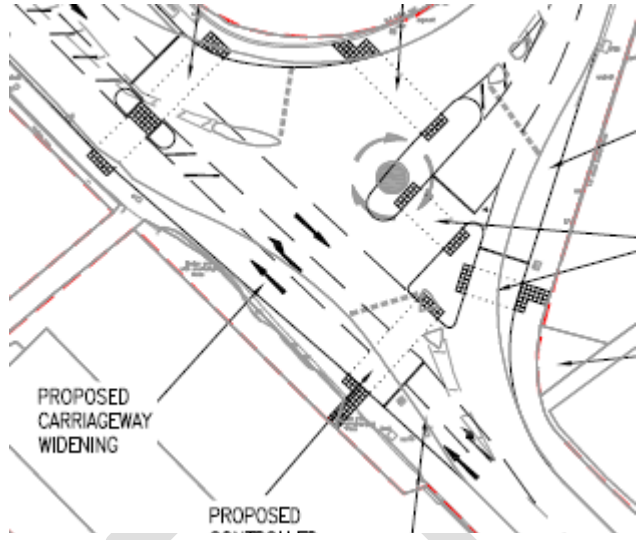
Location Reference No: 16	
<p>Location: Southeast corner of junction (Drg No: 5107918/TP/PD/301)</p>

<p>Problem:</p>	<p>Junctions - Southbound traffic from the north approach is aligned to the southeast corner of the junction.</p>
<p>Summary:</p>	<p>Southbound traffic from the northern approach of the junction is aligned to travel into the southeast corner of the junction when right turning stationary vehicles are waiting to turn in the middle of the junction. This could lead to pedestrian vehicle conflict of vehicles mounting the footway and striking the parapet. In addition, there is a possibility of side swipe collisions with right turning stationary traffic and ahead vehicles.</p>
<p>Recommendation:</p>	<p>Adjust alignment to reduce the risk of vehicles mounting the southeastern kerb.</p>

16	<p>Location: Southeast corner of junction (Drg No: 5107918/TP/PD/301)</p> <p>Problem: Junctions - Southbound traffic from the north approach is aligned to the southeast corner of the junction.</p> <p>Summary: Southbound traffic from the northern approach of the junction is aligned to travel into the southeast corner of the junction when right turning stationary vehicles are waiting to turn in</p>	<p>Adjust alignment to reduce the risk of vehicles mounting the southeastern kerb.</p>	Accepted	<p>This is a replication of the WSCC proposal for the A22 / Lingfield Road scheme. There is a risk of collision for southbound traffic on the A22 with the south-east kerb. The proposed alignment will need to be reviewed at the next design stage.</p>

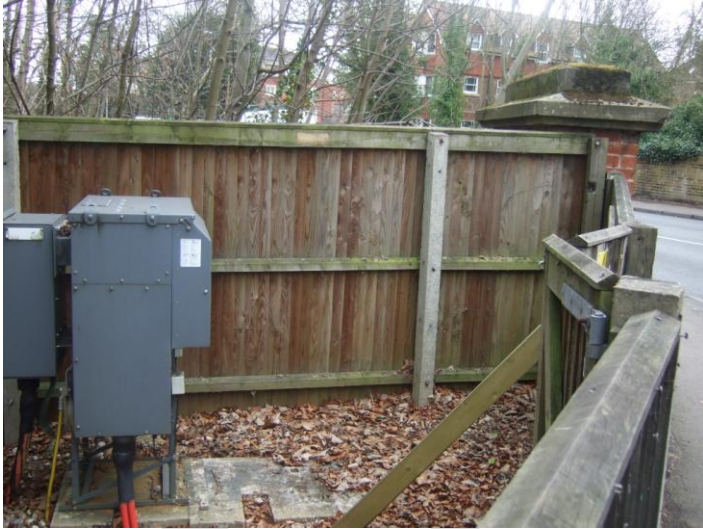
Location Reference No: 17	
<p>Location: Electrical sub-station on southeast corner of junction (Drg No: 5107918/TP/PD/303)</p>

<p>Electrical Sub-station on southeast corner of junction</p>
<p>Problem:</p>	<p>Non Motorised User Provision - Pedestrians walking in live carriageway</p>
<p>Summary:</p>	<p>Although the provision of a cantilever pedestrian footway located behind the electrical sub-station could improve safety for pedestrians, they could perceive walking on the live carriageway as a more convenient route.</p>
<p>Recommendation:</p>	<p>Assess slightly adjusting the fencing boundary of the electrical sub-station to accommodate pedestrians on the south-eastern turn.</p>

Location Ref.	Problem	Recommendation	Accepted/ Rejected	Designer's Response
	<p>the middle of the junction. This could lead to pedestrian vehicle conflict of vehicles mounting the footway and striking the parapet. In addition, there is a possibility of side swipe collisions with right turning stationary traffic and ahead vehicles.</p>			
17	<p>Location: Electrical sub-station on southeast corner of junction (Drg No: 5107918/TP/PD/303)</p> <p>Problem: Non Motorised User Provision - Pedestrians walking in live carriageway</p> <p>Summary: Although the provision of a cantilever pedestrian footway located behind the electrical sub-station could improve safety for pedestrians, they could perceive walking on the live carriageway as a more convenient route.</p>	<p>Assess slightly adjusting the fencing boundary of the electrical sub-station to accommodate pedestrians on the south-eastern turn.</p>	Accepted	<p>Guard rail could be implemented on the footway immediately south of the crossing across Lingfield Road to prevent pedestrian access to the vehicular bridge. This can be considered in more detail at the next design stage.</p>

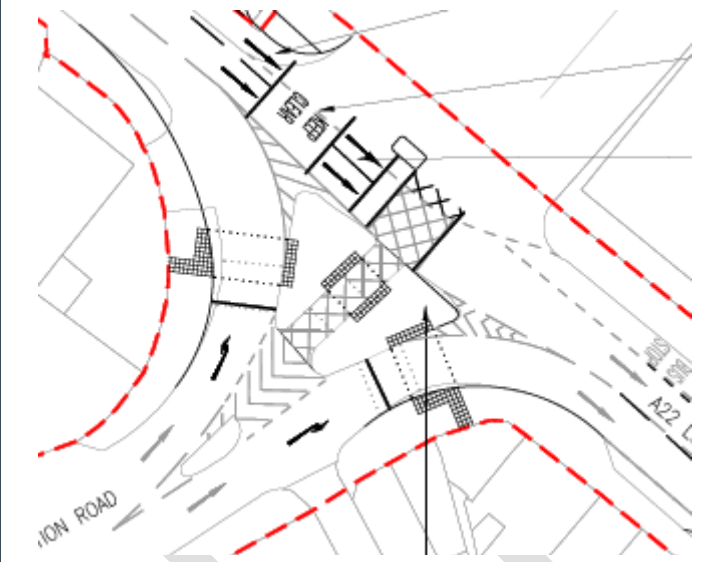
Location Reference No: 18	
<p>Location: Short southbound lane in front of Fire Station on A22 London Road (Drg No: 5107918/TP/PD/401)</p>

<p>Problem:</p>	<p>Non Motorised User Provision - The central crossing area on the western approach for access to Fire Station.</p>
<p>Summary:</p>	<p>The tactile and provision of pedestrian crossing area within the central hatched could be confusing for visually impaired pedestrians as they would not be sure if it was controlled or uncontrolled. Visually impaired pedestrians would also not be aware of when it would be safe to cross.</p>
<p>Recommendation:</p>	<p>Consider the movement of partially sighted persons across this unsignalised section of the island and make provisions for their safe crossing within the island</p>

18	<p>Location: Short southbound lane in front of Fire Station on A22 London Road (Drg No: 5107918/TP/PD/401)</p> <p>Problem: Non Motorised User Provision - The central crossing area on the western approach for access to Fire Station.</p> <p>Summary: The tactile and provision of pedestrian crossing area within the central hatched could be confusing for visually impaired pedestrians as they would not be sure if it was controlled or uncontrolled. Visually impaired pedestrians would also not be aware of when it would be safe to cross.</p>	<p>Consider the movement of partially sighted persons across this unsignalised section of the island and make provisions for their safe crossing within the island</p>	Accepted	<p>It is expected that traffic demand on this approach would be low as it is intended for emergency vehicles only, which would be returning to the fire station. The unsignalised section of the crossing could be signalised to reduce confusion for visually impaired pedestrians. This can be considered in more detail at the next design stage.</p>

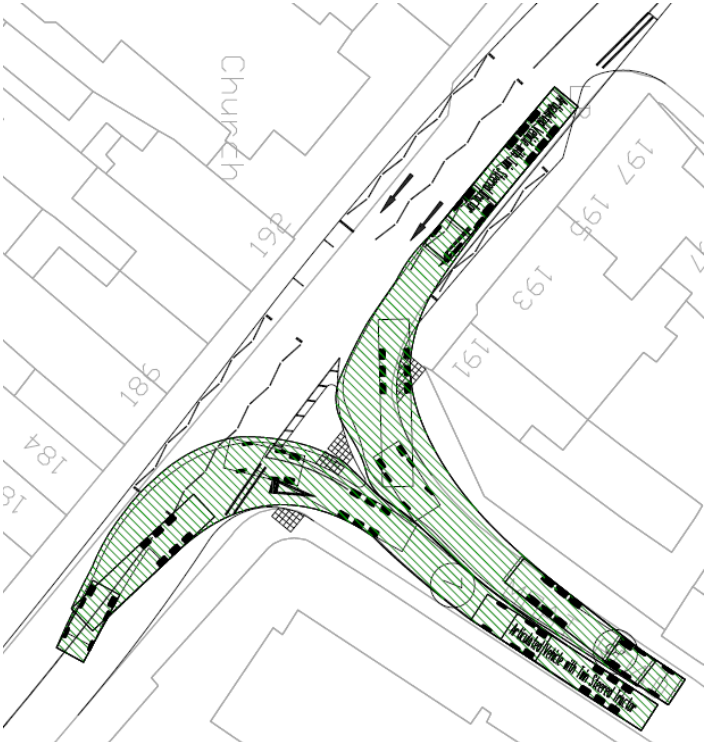
Location Reference No: 20	
<p>Location: HGV left turn (Drg No: 5107918/TP/PD/401)</p>

<p>Autotrack at A22 London Road/Moat Road junction</p>
<p>Problem:</p>	<p>Overrun of HGV into pedestrian area</p>
<p>Summary:</p>	<p>The Autotracks show that in order for HGVs to successfully execute the left turn into and out of Moat Road they would need to overrun the pedestrian areas on Moat Road. Alternatively, HGVs would need to straddle two lanes on A22 London Road conflicting with straight ahead traffic.</p>
<p>Recommendation:</p>	<p>Consider removing the central lane or widening the short left turn lane for the left turn into Moat Road. For the left turn out of Moat Road, consider reducing the size of the central refuge or ban HGVs from turning left into A22 London Road or reduce the proposed kerb buildout.</p>

Location Ref.	Problem	Recommendation	Accepted/ Rejected	Designer's Response
	<p>Problem: Non Motorised User Provision - Pedestrians crossing location</p> <p>Summary: The proposed crossings are located adjacent to one another, and could lead to confusion of partially sighted and blind persons with an array of tactile paving directing them in different directions.</p>			<p>reduce confusion for visually impaired users.</p>
20	<p>Location: HGV left turn (Drg No: 5107918/TP/PD/401)</p> <p>Problem: Overrun of HGV into pedestrian area</p> <p>Summary: The Autotracks show that in order for HGVs to successfully execute the left turn into and out of Moat Road they would need to overrun the pedestrian areas on Moat Road. Alternatively, HGVs would need to straddle two lanes on A22 London Road conflicting with straight ahead traffic</p>	<p>Consider removing the central lane or widening the short left turn lane for the left turn into Moat Road. For the left turn out of Moat Road, consider reducing the size of the central refuge or ban HGVs from turning left into A22 London Road or reduce the proposed kerb buildout.</p>	Accepted	<p>The proposed island cannot be reduced in width due to the need to provide tactile paving and maintain the crossing on the pedestrian desire line associated with the alignment of the A22 London Road. Additional land take would be required to permit an HGV to turn left from the A22 London Road nearside lane onto Moat Road.</p> <p>In the proposed layout an HGV would be able to complete the left turn onto Moat Road from the central lane on the A22 London Road.</p> <p>To enable HGVs to complete the left turn from Moat Road land take will be required.</p>

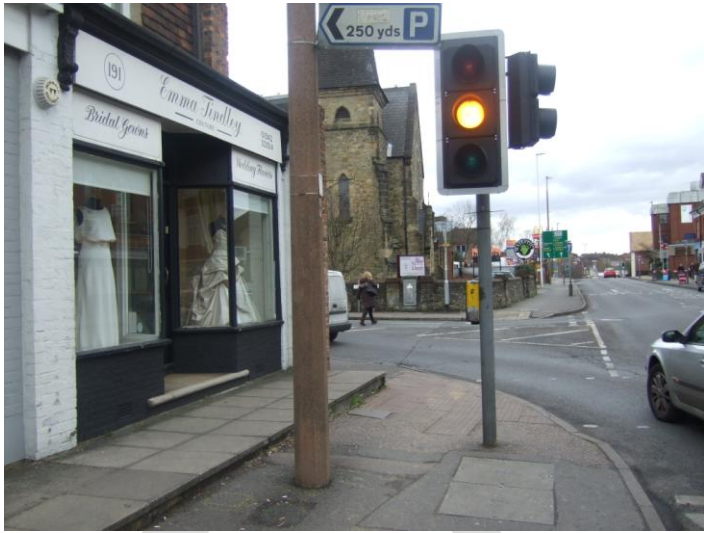
Location Reference No: 21	
<p>Location: A22 London Road between Station Road and Moat Road(Drg No: 5107918/TP/PD/402)</p>

<p>A22 London Road/ Moat Road junction</p>
<p>Problem:</p>	<p>Non Motorised User Provision - Provision of controlled crossings at a signalised junction</p>
<p>Summary:</p>	<p>The proposed layout of the junction may encourage pedestrians to cross the junction away from the crossing facilities and risk coming into conflict with vehicles.</p>
<p>Recommendation:</p>	<p>Consider relocating the crossings to suit pedestrian desire lines or either provide guard railing to guide pedestrians to dedicated crossing points.</p>

21	<p>Location: A22 London Road between Station Road and Moat Road(Drg No: 5107918/TP/PD/402)</p> <p>Problem: Non Motorised User Provision - Provision of controlled crossings at a signalised junction</p> <p>Summary: The proposed layout of the junction may encourage pedestrians to cross the junction away from the crossing facilities and risk coming into conflict with vehicles.</p>	<p>Consider relocating the crossings to suit pedestrian desire lines or either provide guard railing to guide pedestrians to dedicated crossing points.</p>	Accepted	<p>Due to the alignment of the A22 London Road it is necessary to provide a staggered crossing across Moat Road to avoid northbound pedestrians being directed into the carriageway. Therefore, the proposed crossing is staggered.</p> <p>Guard railing could be implemented at this location and will be considered further at the next design stage.</p>

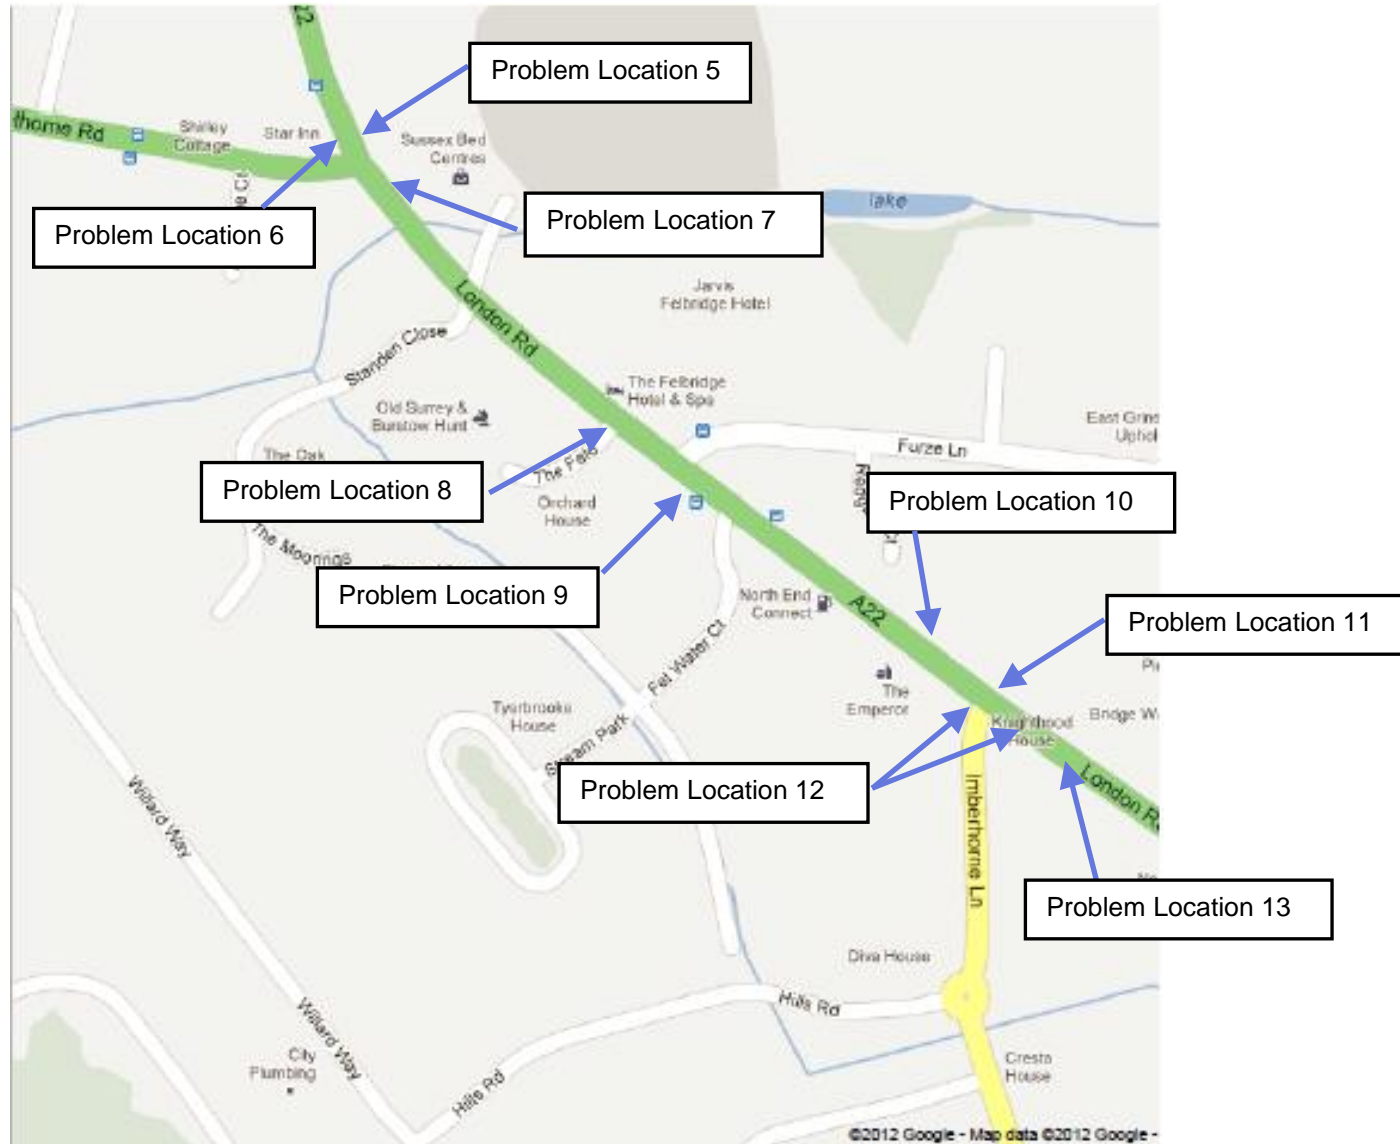
Problem Location Plan No 1

3.1 Unless general to the scheme, the annotated plan in Appendix C indicates the locations of the safety problems raised in this section and are cross-referenced to the location reference numbers attributed to each problem.
